ECO INSPECTION CERTIFICATE

Order ID : 42794

121 Points Vehicle Inspection Certificate

Ford Figo Duratorq Zxi 1.4, 2011

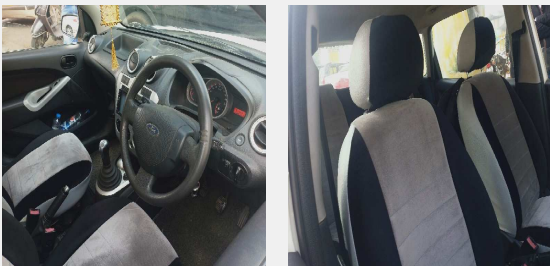
IMAGES

INTERIOR

INSPECTION CHECKPOINTS	SCORE(X/10)	REMARKS/COMMENTS	OPTIONAL SPEND EST. (RS)
DOOR PANEL	6		0
DOOR HINGES	6		0
CARPET & FLOOR MAT	6		0
SEAT & SEAT BELT	6		0
DASHBOARD & INSTRUMENT PANEL	6		0
HORN	6		0
SPEAKERS & MUSIC SYSTEM	6		0
HANDBRAKE	6		0
STEERING-MOUNTED CONTROLS	6		0
PEDALS	6		0
CENTRAL LOCK	6		0
A/C VENTS & HEATER	6		0
CUP HOLDERS	6		0
NAVIGATION (NO)	10		0
ODOMETER	7		0
POWER WINDOWS (YES - FRONT ONLY)	7		0
HAZARD LIGHT	7		0

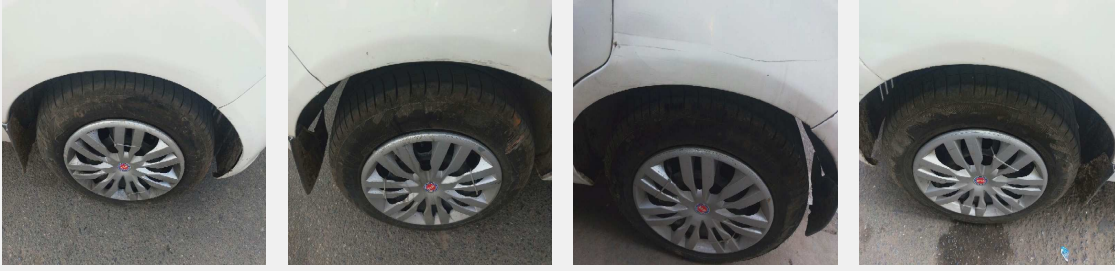
IMAGES

WHEEL

INSPECTION CHECKPOINTS	SCORE(X/10)	REMARKS/COMMENTS	OPTIONAL SPEND EST. (RS)
TYRES	8		0
SPARE TYRE (YES)	6		0
WHEEL ASSEMBLY (STEEL RIM)	7		0

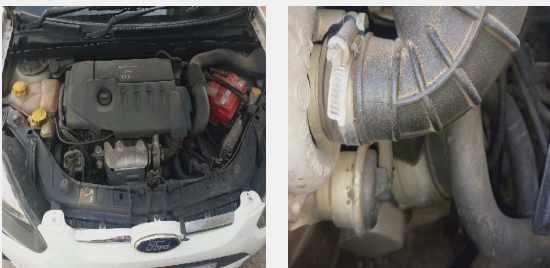
IMAGES

HOOD

INSPECTION CHECKPOINTS	SCORE(X/10)	REMARKS/COMMENTS	OPTIONAL SPEND EST. (RS)
LH APRON	6		0
RH APRON	6		0
RADIATOR	6		0
WIRING	6		0
BATTERY	6		0
BRAKE FLUID LEVEL	7		0
ENGINE OIL	6		0
COOLANT LEVEL	7		0
BRAKE & COOLANT HOSE PIPES	6		0
UNDERCARRIAGE	6		0
EXHAUST SYSTEM	6		0
