# ECO INSPECTION CERTIFICATE

Order ID : 42850

121 Points Vehicle Inspection Certificate

## Ford Endeavour 3.0L 4X4 AT, 2010

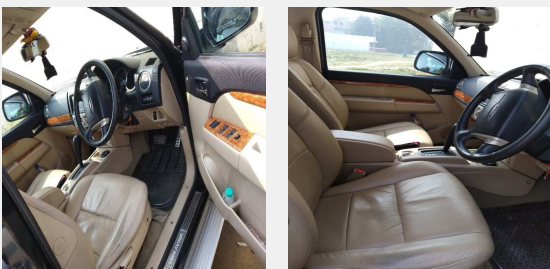
## IMAGES

INSPECTION CHECKPOINTS	SCORE(X/10)	REMARKS/COMMENTS	OPTIONAL SPEND EST. (RS)
DOOR PANEL	7	GOOD	0
DOOR HINGES	7	GOOD	0
CARPET & FLOOR MAT	7	GOOD	0
SEAT & SEAT BELT	7	GOOD	0
DASHBOARD & INSTRUMENT PANEL	7	GOOD	0
HORN	7	GOOD	0
SPEAKERS & MUSIC SYSTEM	7	GOOD	0
HANDBRAKE	7	GOOD	0
PEDALS	7	GOOD	0
CENTRAL LOCK	7	GOOD	0
A/C VENTS & HEATER	7	GOOD	0
CUP HOLDERS	7	GOOD	0
NAVIGATION (YES)	7	GOOD	0
ODOMETER	7	GOOD	0
POWER WINDOWS (YES)	7	GOOD	0
HAZARD LIGHT	7	GOOD	0
STEERING-MOUNTED CONTROLS	0	NA	0

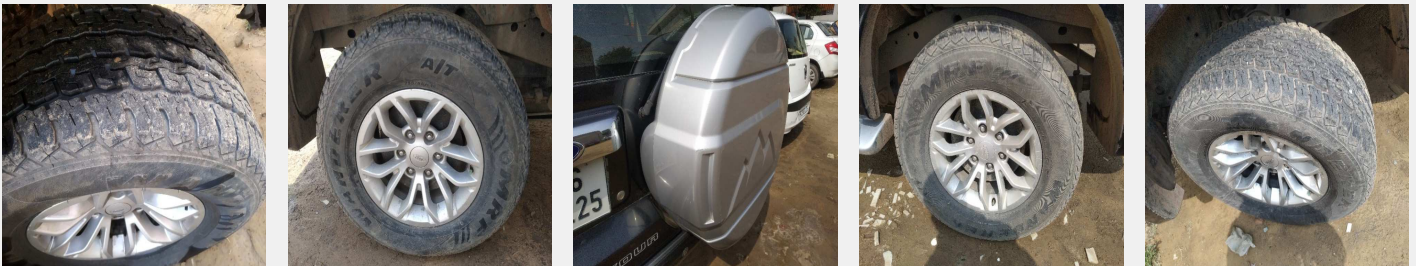
## IMAGES

INSPECTION CHECKPOINTS	SCORE(X/10)	REMARKS/COMMENTS	OPTIONAL SPEND EST. (RS)
TYRES	7	GOOD	0
SPARE TYRE (YES)	7	GOOD	0
WHEEL ASSEMBLY (ALLOY RIM)	7	GOOD	0

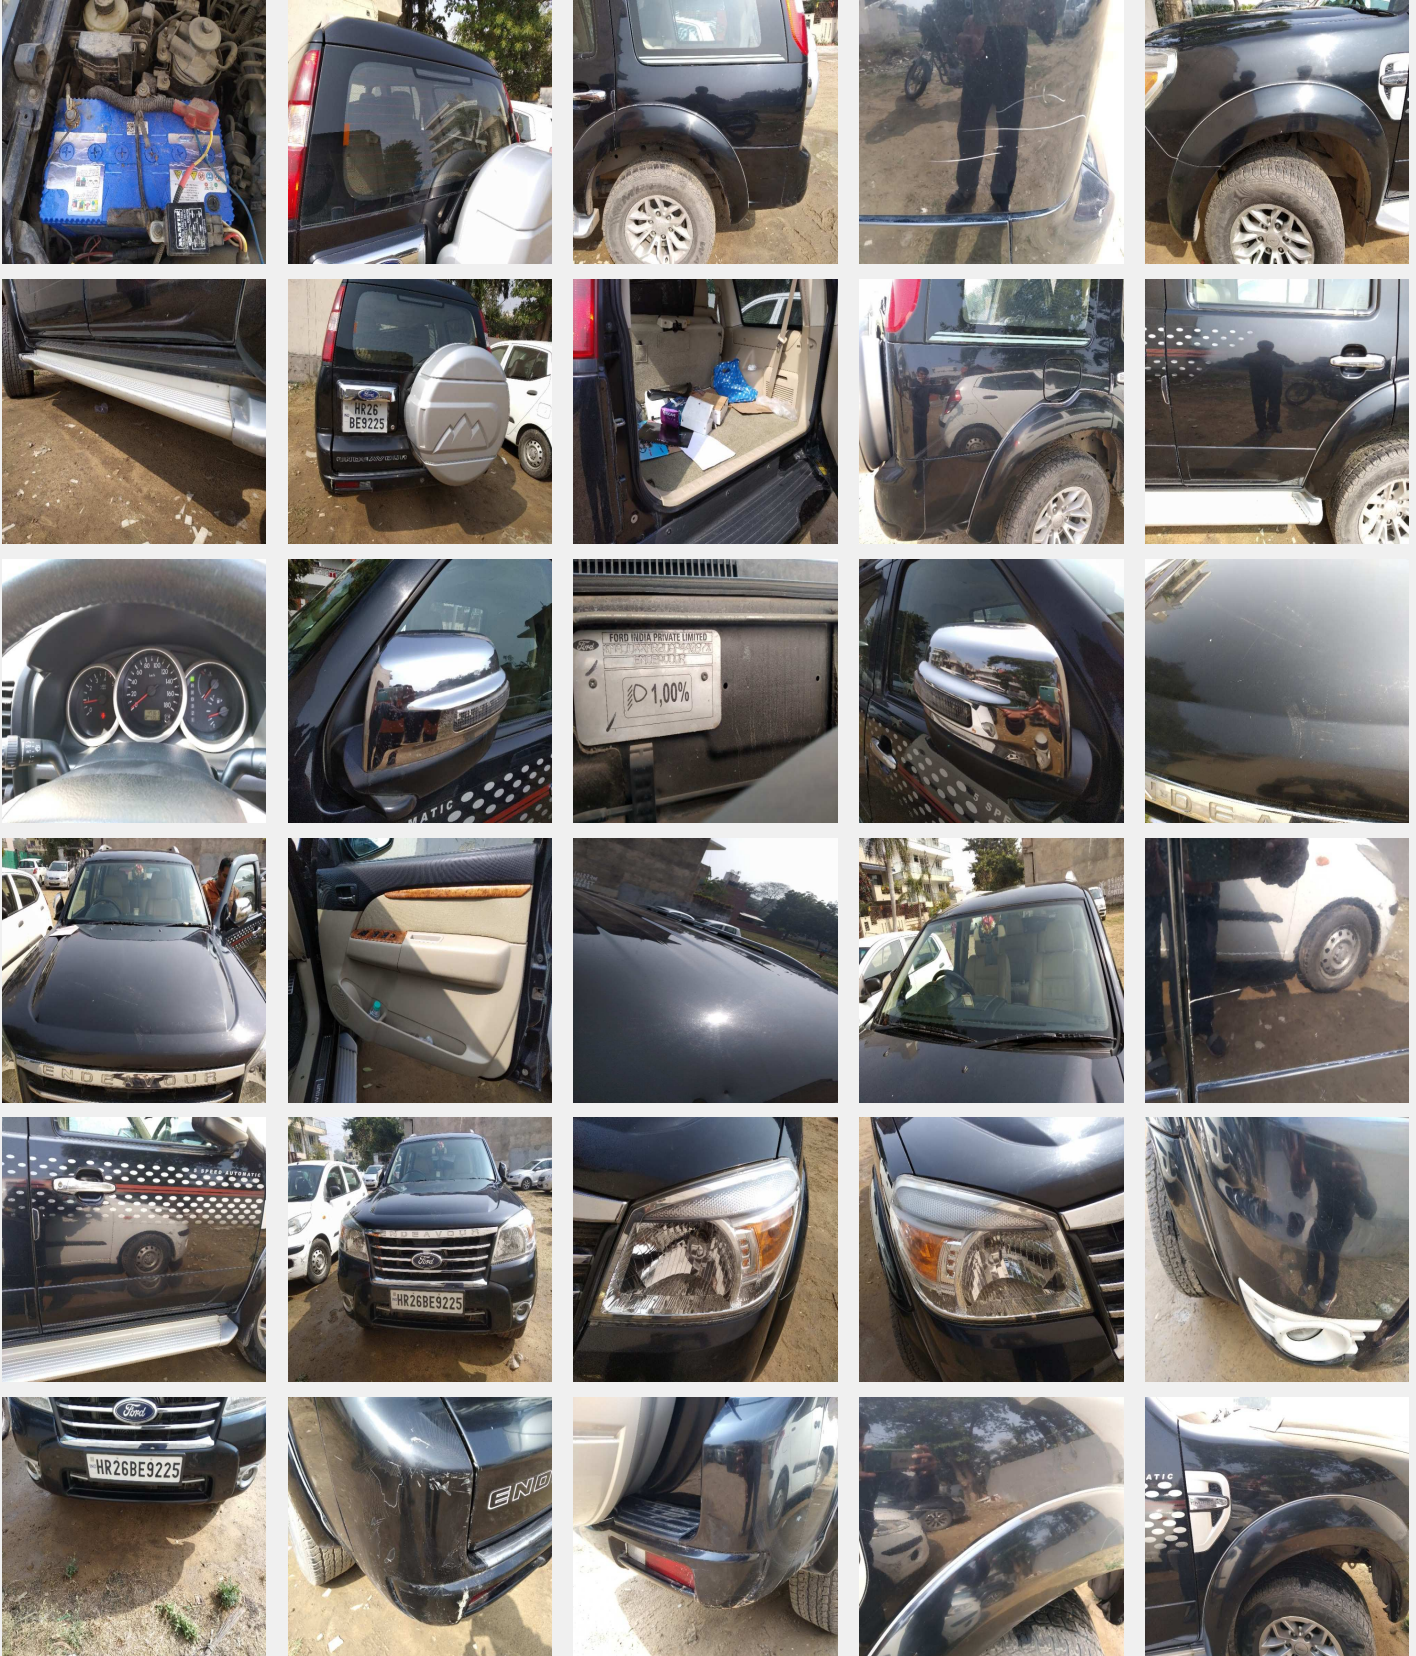
IMAGES

minor scratches and minor dent all tyres already changed
