ECO INSPECTION CERTIFICATE

Order ID : 44043

121 Points Vehicle Inspection Certificate

Maruti Suzuki Wagon R LX, 2007

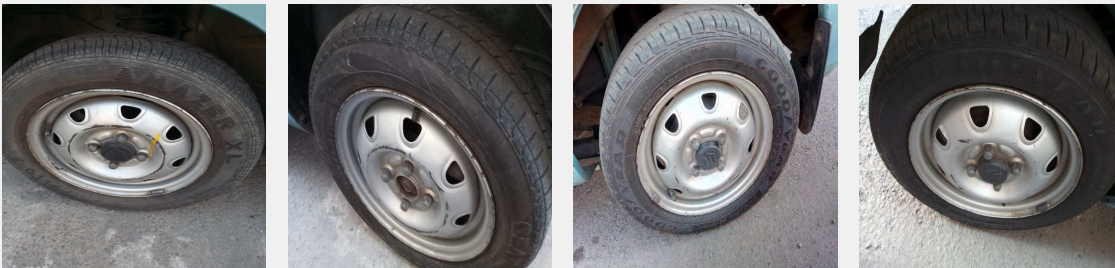
IMAGES

INSPECTION CHECKPOINTS	SCORE(X/10)	REMARKS/COMMENTS	OPTIONAL SPEND EST. (RS)
TYRES	7	OK	0
SPARE TYRE (YES)	6	OK	0
WHEEL ASSEMBLY (STEEL RIM)	6	OK	0

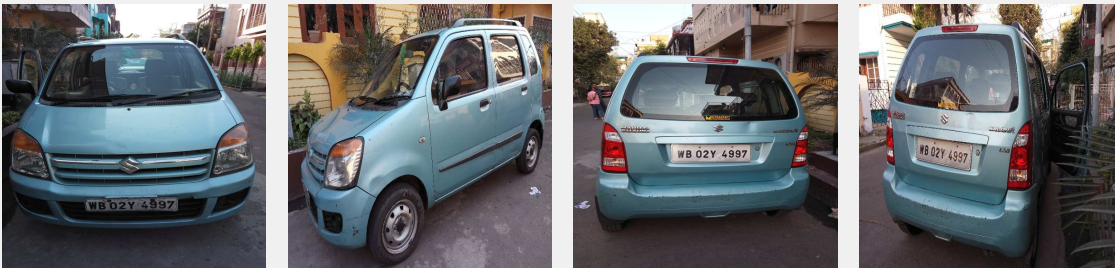
IMAGES

INSPECTION CHECKPOINTS	SCORE(X/10)	REMARKS/COMMENTS	OPTIONAL SPEND EST. (RS)
LH FENDER	5	DENT	1000
LH QUARTER PANEL	5	DENT	1500
REAR BUMPER	5	DENT	1500
RH FENDER	5	DENT	1500
PAINT CONDITION	5	REQUIRED	20000
