ECO INSPECTION CERTIFICATE

Order ID : 53864

121 Points Vehicle Inspection Certificate

Tata Nano STD, 2010

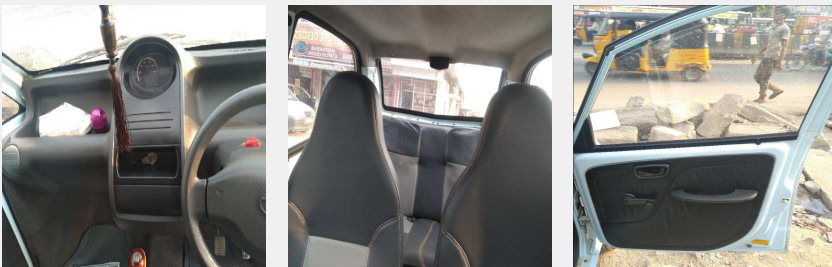
INTERIOR

INSPECTION CHECKPOINTS	SCORE(X/10)	REMARKS/COMMENTS	OPTIONAL SPEND EST. (RS)
DOOR PANEL	9		0
DOOR HINGES	10		0
CARPET & FLOOR MAT	9		0
SEAT & SEAT BELT	10		0
DASHBOARD & INSTRUMENT PANEL	9		0
HORN	10		0
HANDBRAKE	9		0
STEERING-MOUNTED CONTROLS	9		0
PEDALS	9		0
NAVIGATION (NO)	10		0
ODOMETER	8		0
POWER WINDOWS (NO)	10		0
HAZARD LIGHT	8		0
SPEAKERS & MUSIC SYSTEM	0	NO SOUND SYSTEM	1900
CENTRAL LOCK	0	NO CENTRAL LOCK	2500
A/C VENTS & HEATER	0	NO AC	5000
CUP HOLDERS	0	NO HOLDERS	1
