ECO INSPECTION CERTIFICATE

121 Points Vehicle Inspection Certificate

| Ordered By : Suhaib | Inspection Date : 2019-04-12 | Location : ALLAHABAD |

Volkswagen Polo GT TDI, 2014

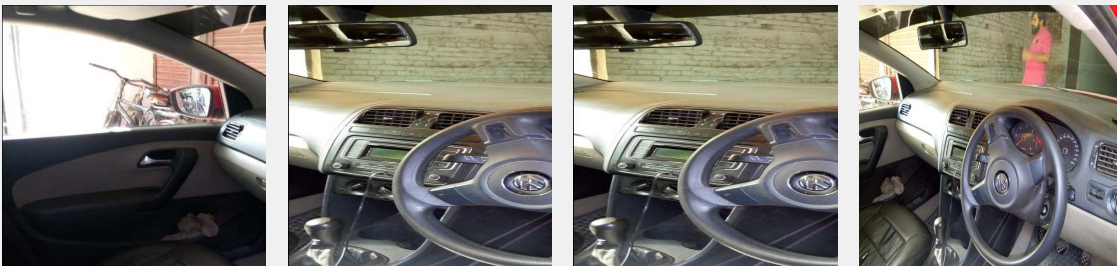
IMAGES

INTERIOR

8/10

| INSPECTION CHECKPOINTS | SCORE(X/10) | REMARKS/COMMENTS | OPTIONAL SPEND EST. (RS) |
| DOOR PANEL | 8 | OK | 0 |
| DOOR HINGES | 7 | OK | 0 |
| CARPET & FLOOR MAT | 8 | OK | 0 |
| SEAT & SEAT BELT | 7 | OK | 0 |
| DASHBOARD & INSTRUMENT PANEL | 8 | OK | 0 |
| HORN | 9 | OK | 0 |
| SPEAKERS & MUSIC SYSTEM | 8 | OK | 0 |
| HANDBRAKE | 6 | OK | 0 |
| STEERING-MOUNTED CONTROLS | 8 | OK | 0 |
| PEDALS | 7 | OK | 0 |
| CENTRAL LOCK | 8 | OK | 0 |
| A/C VENTS & HEATER | 7 | OK | 0 |
| CUP HOLDERS | 8 | OK | 0 |
| ODOMETER | 8 | OK | 0 |
| POWER WINDOWS (YES - FRONT ONLY) | 6 | OK | 0 |
| HAZARD LIGHT | 8 | OK | 0 |

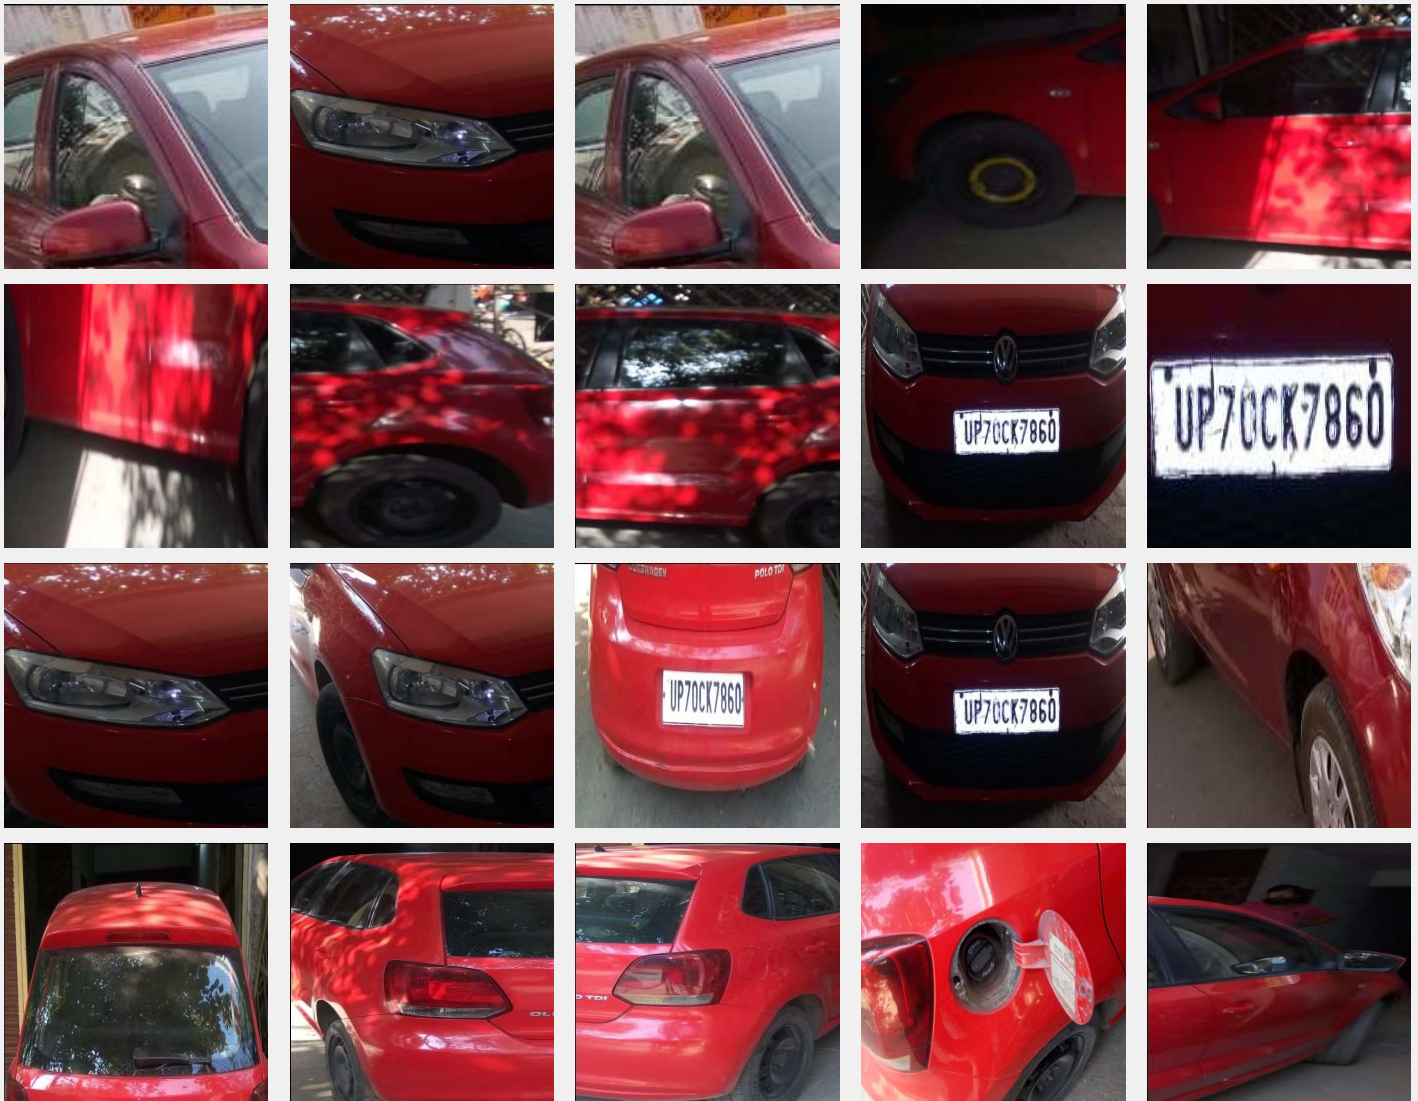
IMAGES

| INSPECTION CHECKPOINTS | SCORE(X/10) | REMARKS/COMMENTS | OPTIONAL SPEND EST. (RS) |
|---|---|---|---|
| BODY RUST | 8 | OK | 0 |
| PAINT CONDITION | 8 | OK | 0 |
