# ECO INSPECTION CERTIFICATE

Order ID : 75681

121 Points Vehicle Inspection Certificate

## Maruti Suzuki Esteem VXi BS II, 2005

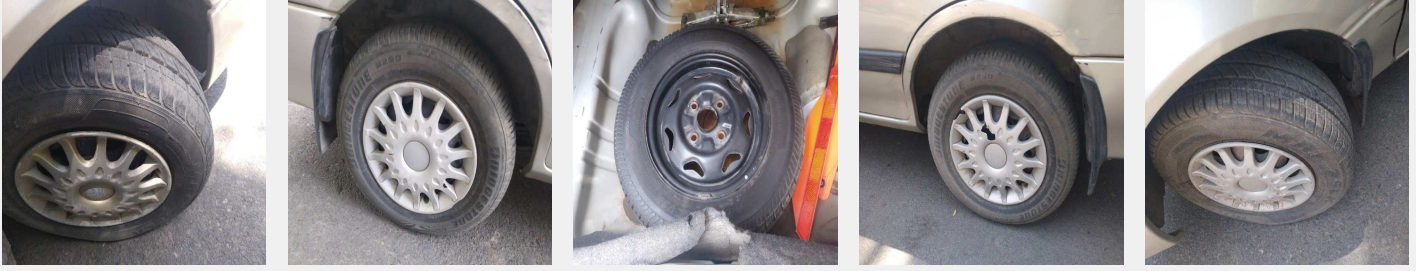
| INSPECTION CHECKPOINTS | SCORE(X/10) | REMARKS/COMMENTS | OPTIONAL SPEND EST. (RS) |
|---|---|---|---|
| TYRES | 7 | | 0 |
| SPARE TYRE (YES) | 7 | | 0 |
| WHEEL ASSEMBLY (STEEL RIM) | 7 | | 0 |

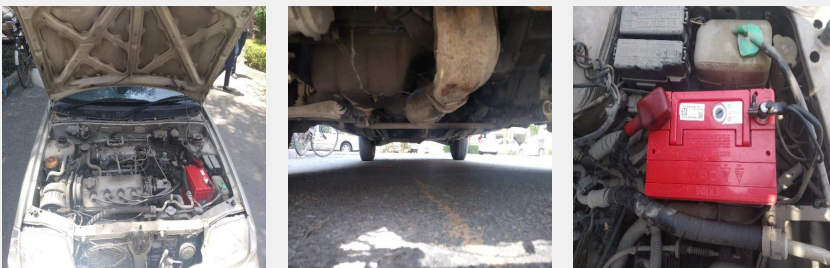
## HOOD

| INSPECTION CHECKPOINTS | SCORE(X/10) | REMARKS/COMMENTS | OPTIONAL SPEND EST. (RS) |
|---|---|---|---|
| EXHAUST SYSTEM | 7 | | 0 |
